1040-1050 7th Ave SW, Albany, OR 97321

**7th St. Due Diligence  
Opinion of Cost  
May 19th, 2024**

Evolution was retained by Linn County Facilities to review the condition and expected service life of existing the existing structure. The building consists of 2 original wood framed structures which were subsequently combined into a single structure.

## Summary Condition Assessment

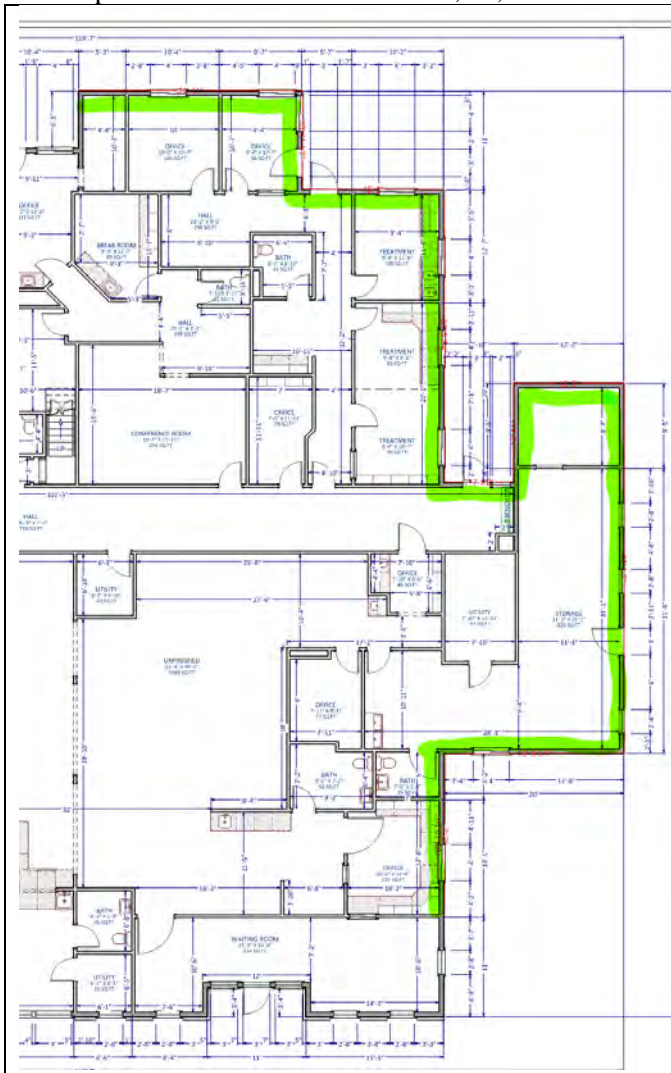
1<sup>st</sup> Floor recommended siding replacement

In the immediate term we recommend replacing the West portion of the roof, siding at the 2<sup>nd</sup> floor and lap siding at the South and West elevations. Siding on the South can be limited to the exposed portion highlighted in the quantity takeoff below left. As budget allows replacing all pressboard lap siding is recommended. The exposed fascia condition at the E, W, N elevations should also be remediated.

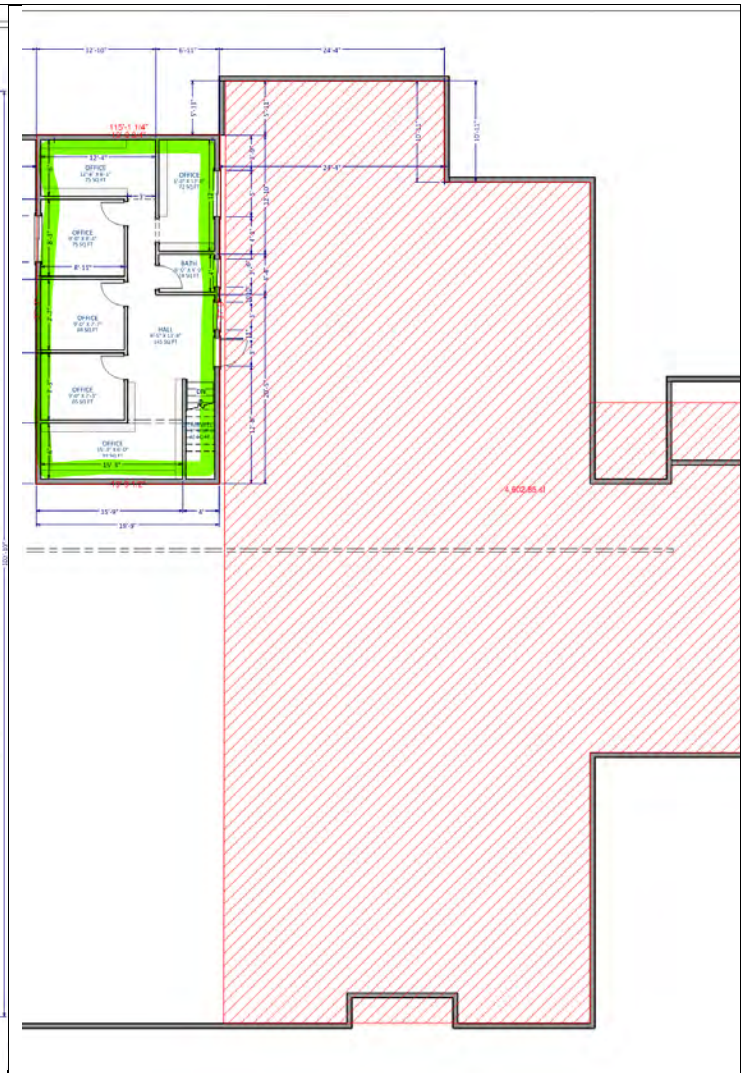
2<sup>nd</sup> floor recommended siding replacement

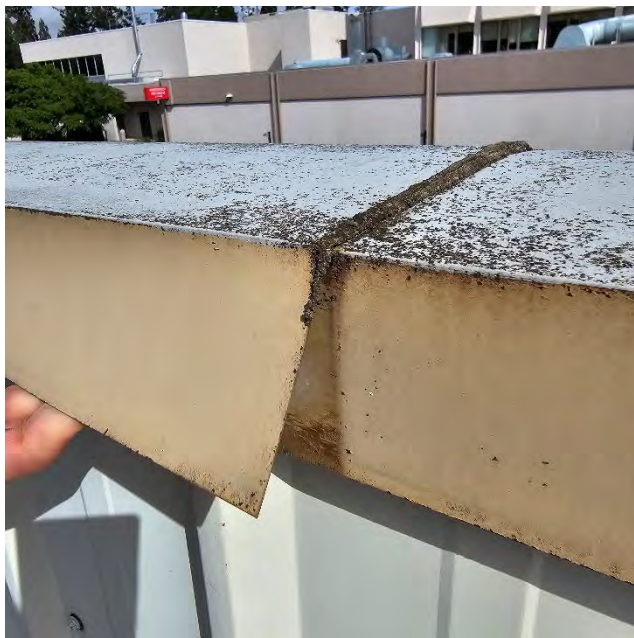
**Photo 2.11:** Loose parapet connection

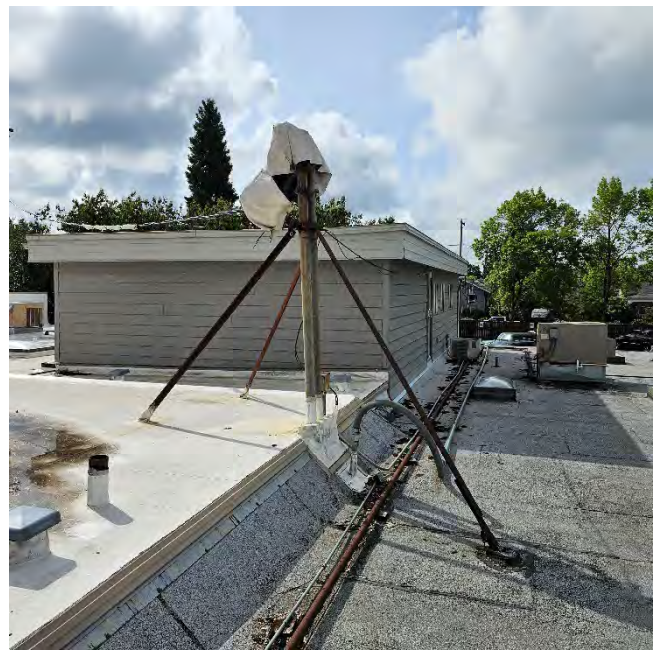
**Photo 2.12:** Roof weatherhead

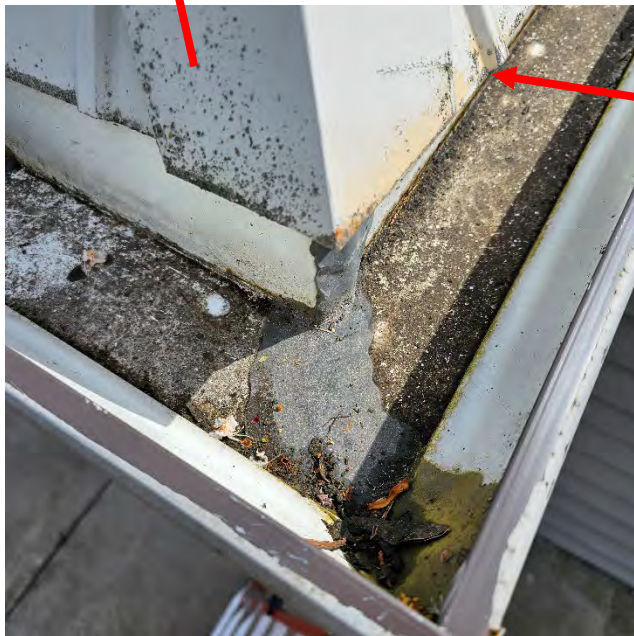
**Photo 3.9:** Mansard to gutter outside corner condition

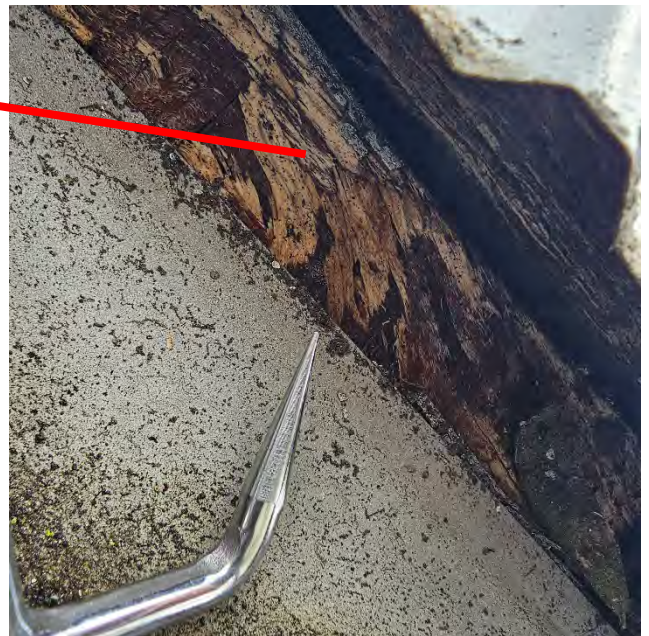
**Photo 3.10:** Exposed sheathing at upper edge of gutter

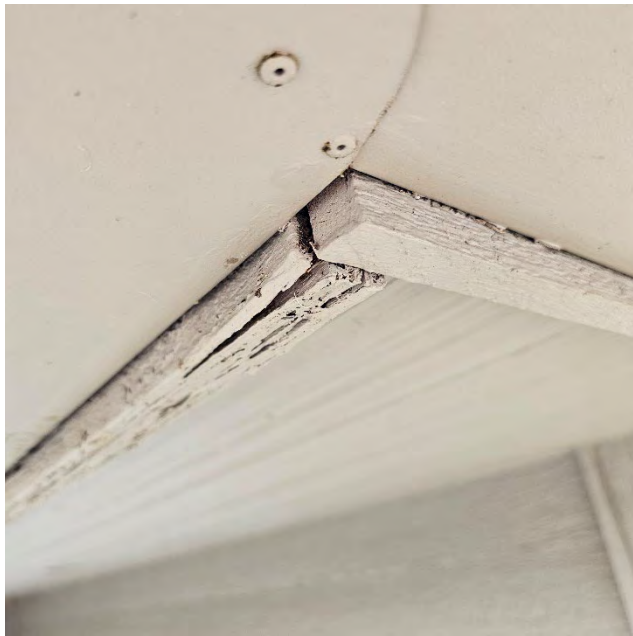
**Photo 3.11:** Water damaged fascia at outside corner (typ)

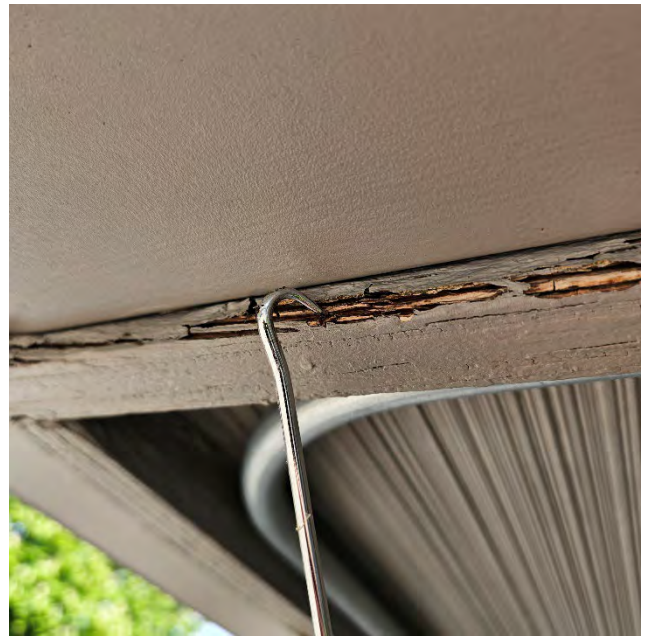
**Photo 3.12:** Water damaged fascia

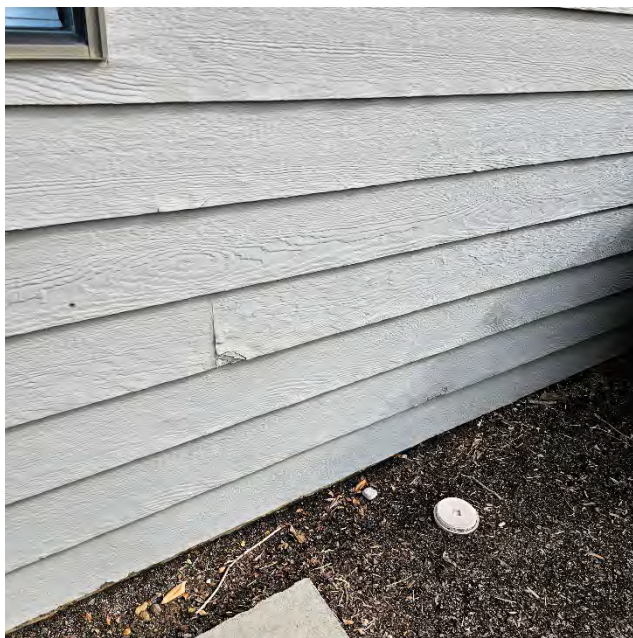
**Photo 3.13:** Delaminating siding at West elevation

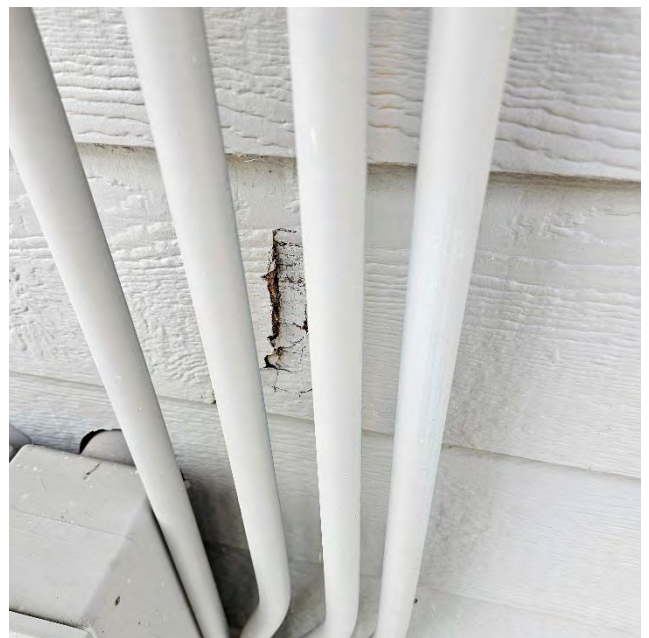
**Photo 3.14:** Damaged siding at utility penetrations

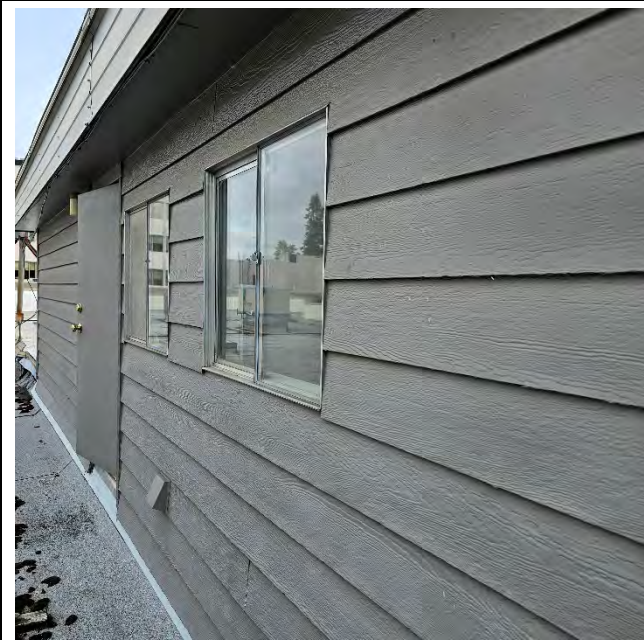
**Photo 3.15:** Siding at 2<sup>nd</sup> floor

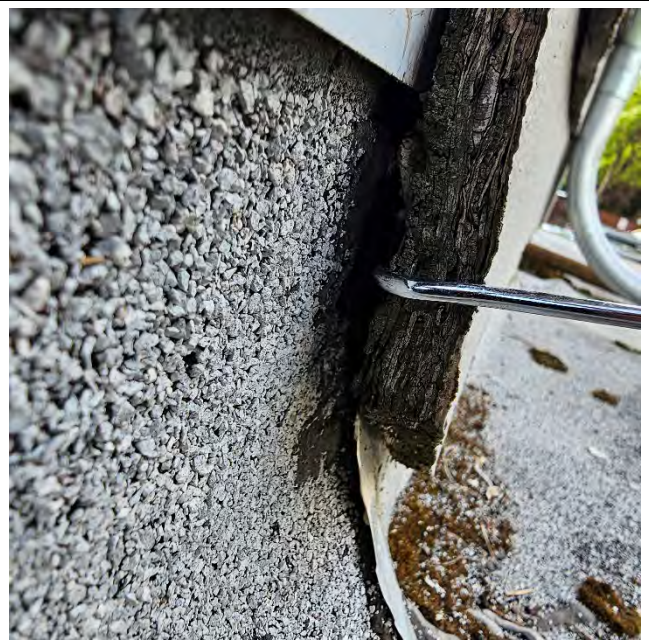
**Photo 3.16:** Siding edge condition

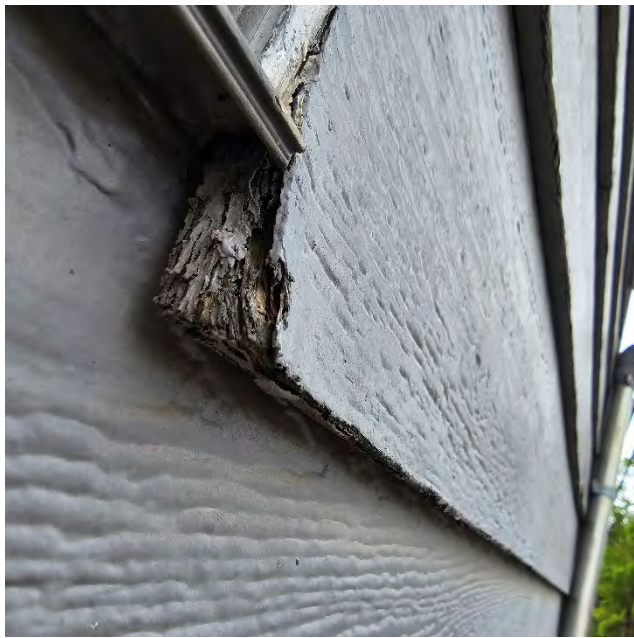
**Photo 3.17:** Siding edge condition at 2<sup>nd</sup> floor door

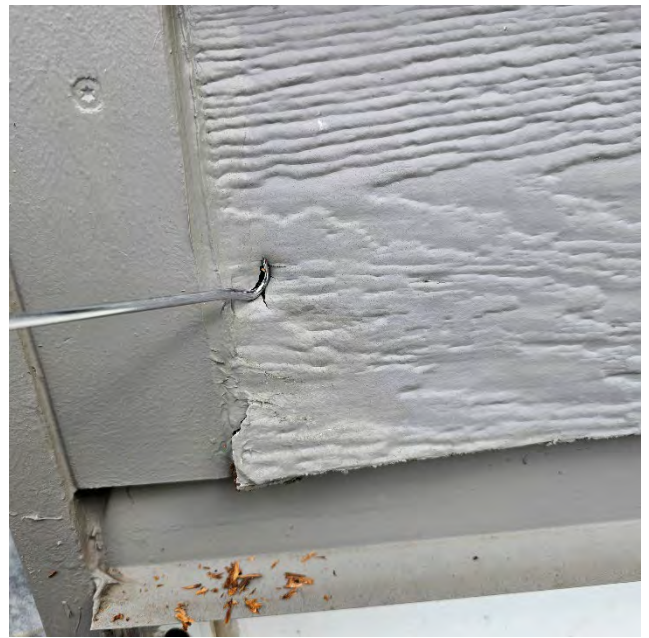
**Photo 3.18:** Siding condition

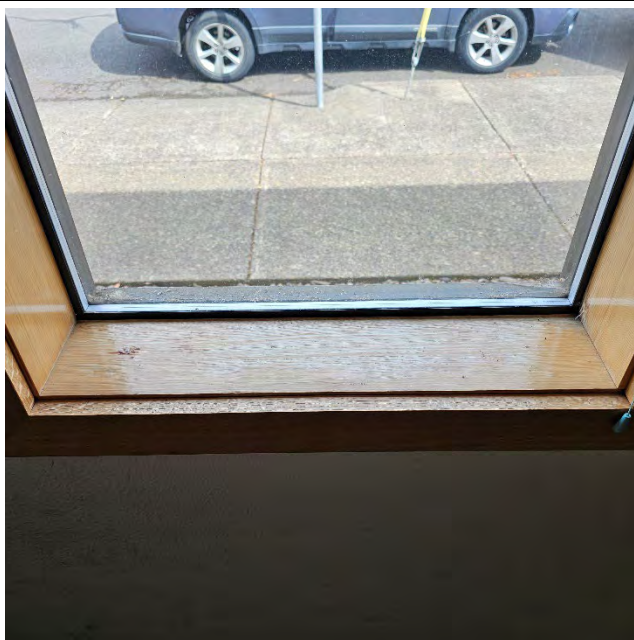
**Photo 4.5:** Sealant failure at West edge of North curtain wall

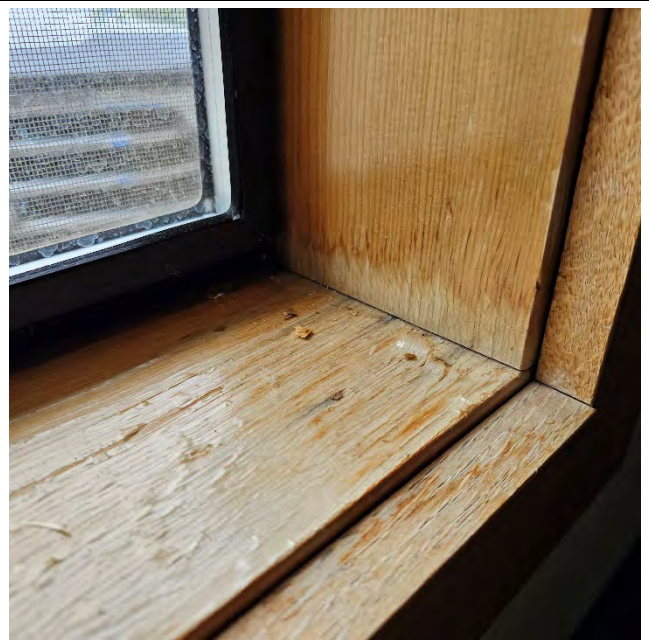
**Photo 4.6:** Sealant failure detail

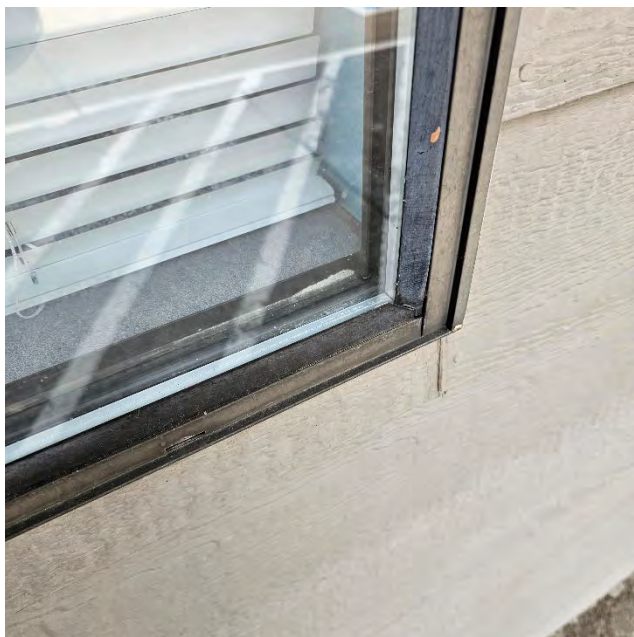
**Photo 4.7:** Typical storefront at ground level

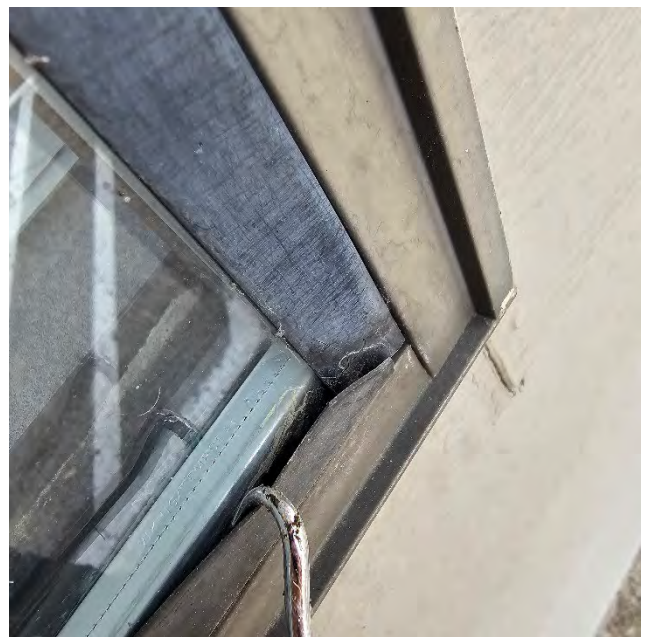
**Photo 4.8:** Damaged window frame (2201)

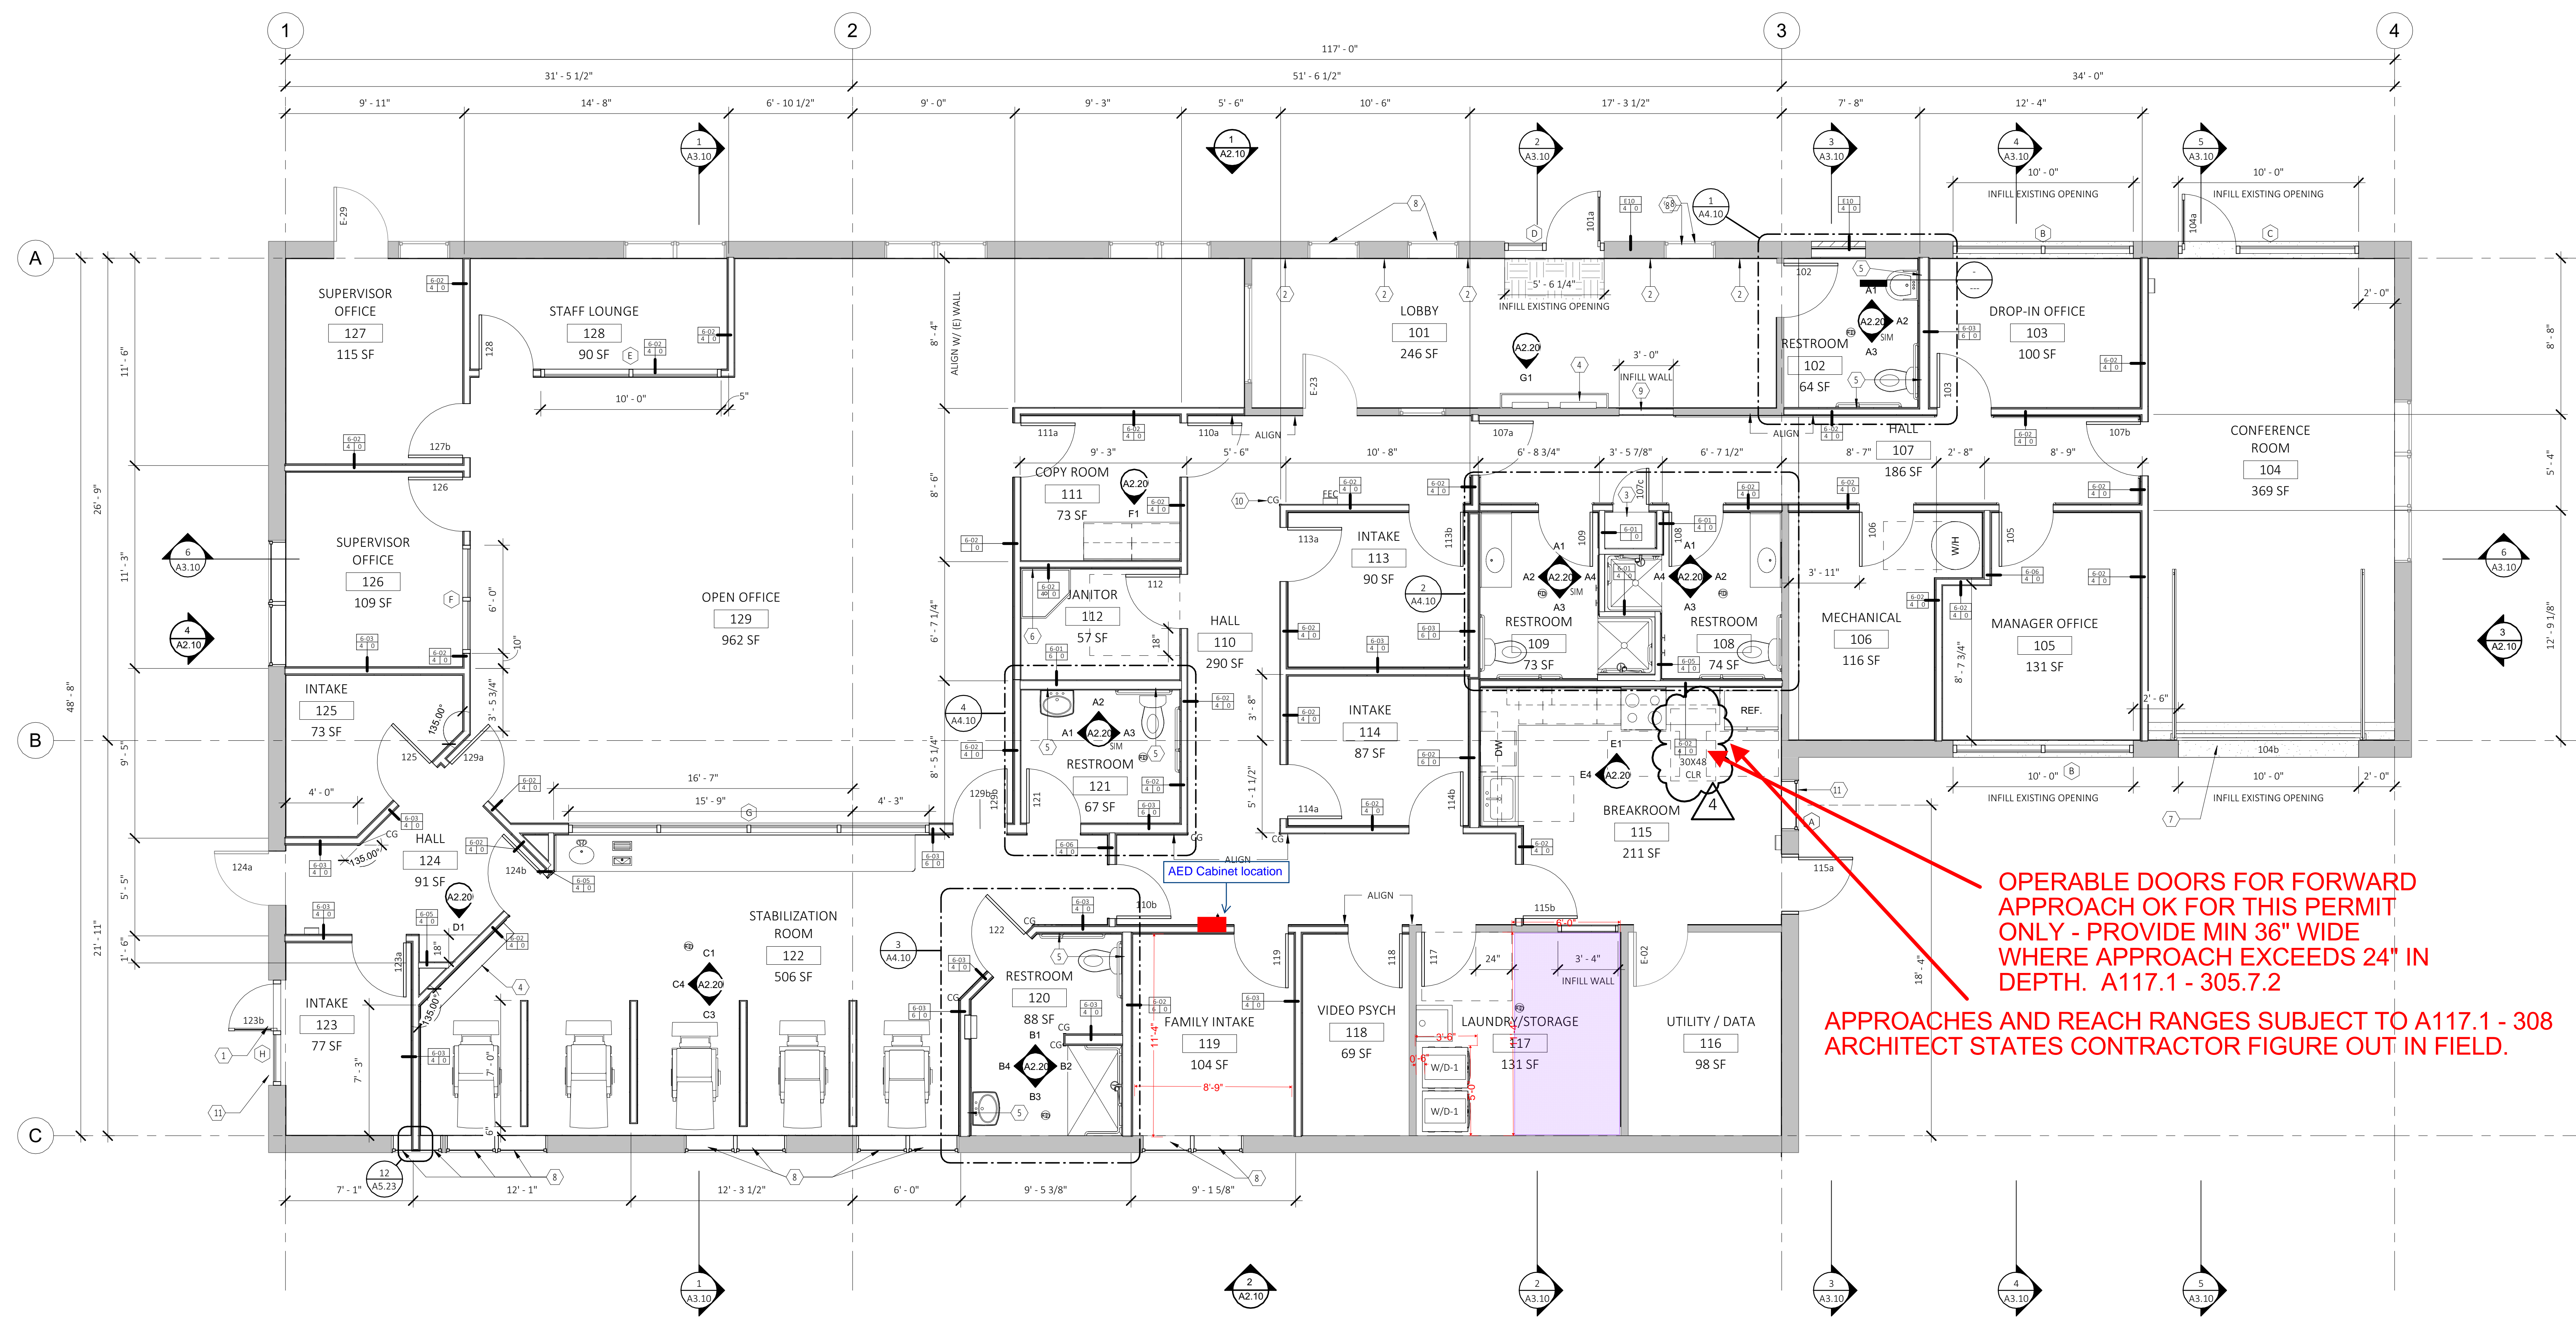
**OPERABLE DOORS FOR FORWARD APPROACH OK FOR THIS PERMIT ONLY - PROVIDE MIN 36" WIDE WHERE APPROACH EXCEEDS 24" IN DEPTH. A117.1 - 305.7.2**

**APPROACHES AND REACH RANGES SUBJECT TO A117.1 - 308 ARCHITECT STATES CONTRACTOR FIGURE OUT IN FIELD.**
