1040-1050 7th Ave SW, Albany, OR 97321

**7th St. Due Diligence  
Opinion of Cost  
May 19th, 2024**

Evolution was retained by Linn County Facilities to review the condition and expected service life of existing the existing structure. The building consists of 2 original wood framed structures which were subsequently combined into a single structure.

## Summary Condition Assessment

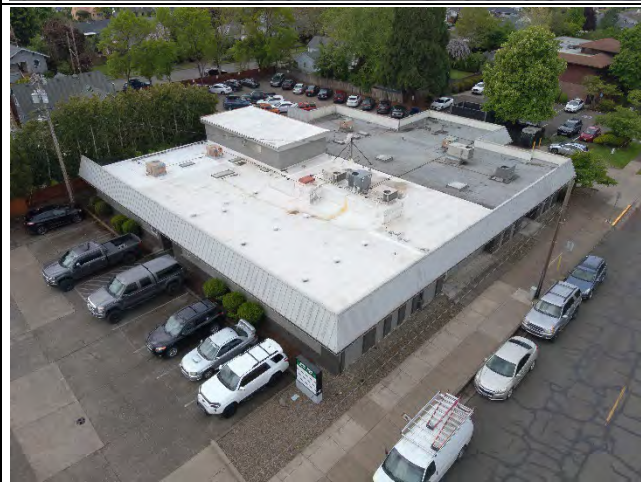
**Photo 2.1:** East roof overview

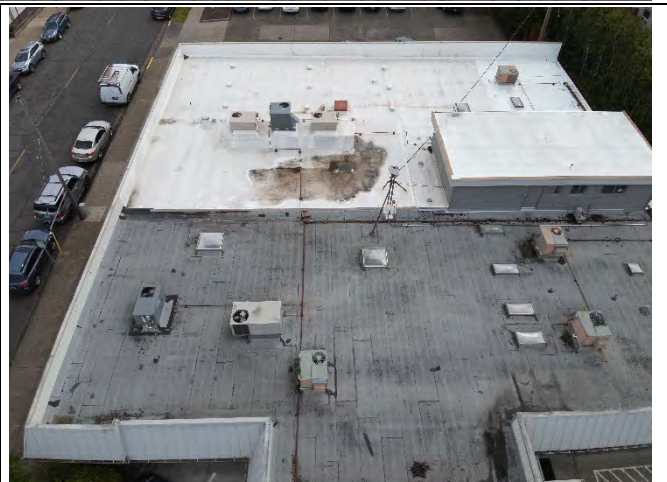
Overall the roof is separated at the West edge of the 2<sup>nd</sup> floor. The West section of the roof is in poor condition and should be replaced. The membrane is in poor condition with significant granule loss and many locations with evidence of prior patching. The parapet shows evidence of prior patching attempts and poor cap flashing overlaps and fastening. The mansard to gutter termination is problematic throughout as there is not a positive connection and the fascia is exposed at the interior edge of gutters. Water damage is evident at several locations where this condition occurs. The East section of the roof consists of duro-last membrane and appears serviceable.

**Photo 2.2:** West roof overview

In the immediate term we recommend replacing the West portion of the roof, siding at the 2<sup>nd</sup> floor and lap siding at the South and West elevations. Siding on the South can be limited to the exposed portion highlighted in the quantity takeoff below left. As budget allows replacing all pressboard lap siding is recommended. The exposed fascia condition at the E, W, N elevations should also be remediated.

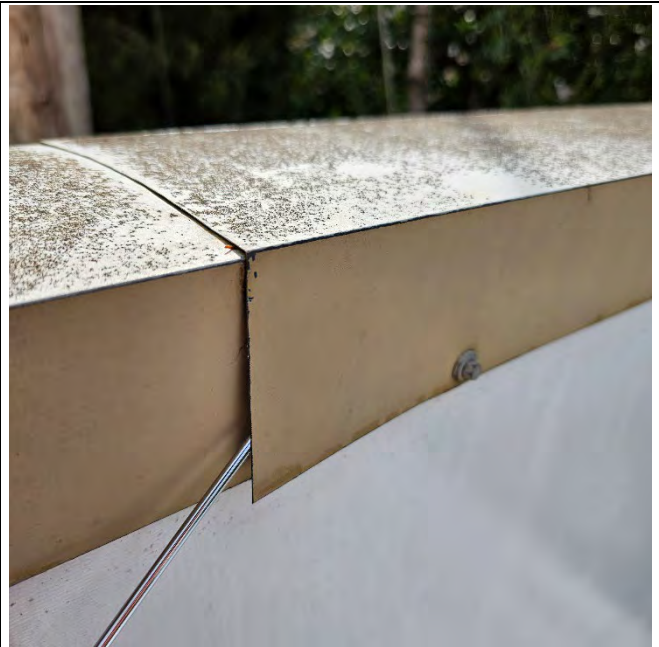
**Photo 2.4:** Parapet overlap at East roof

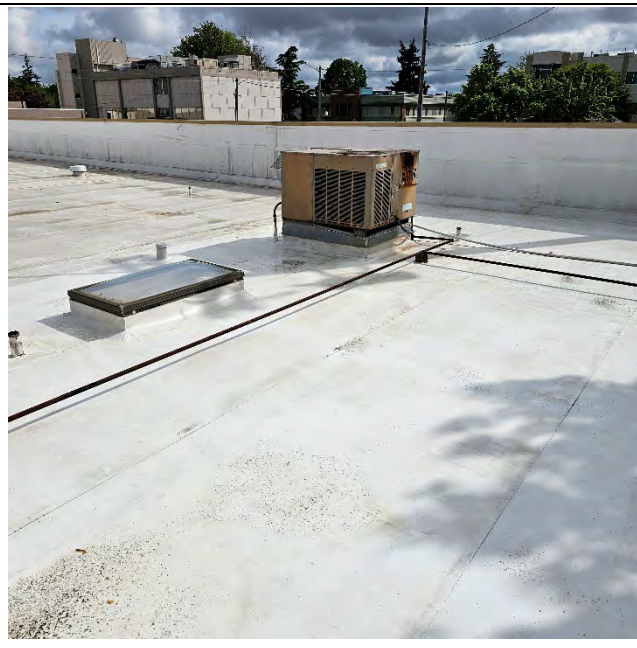
**Photo 2.5:** Curb mounted skylight and hvac unit

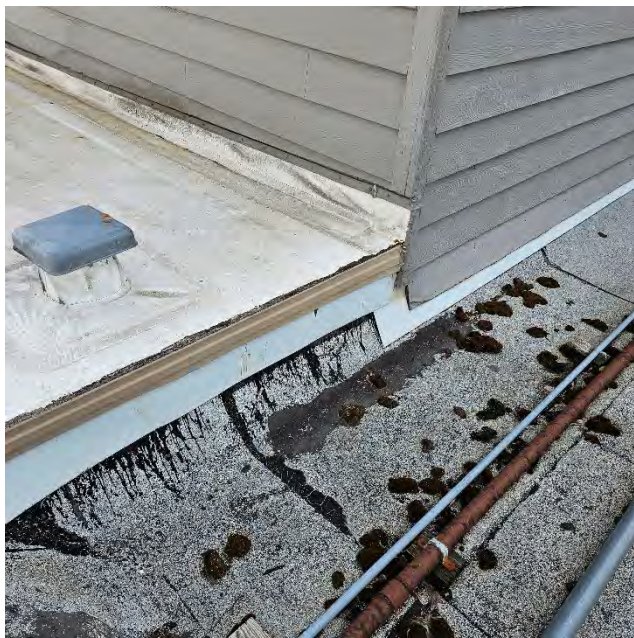
**Photo 2.7:** East to West roof transition

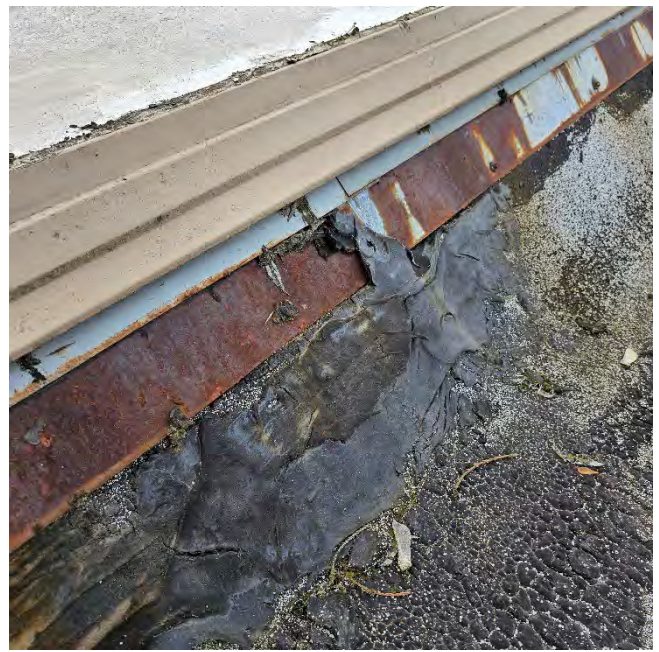
**Photo 2.8:** Multiple layers of transition flashing

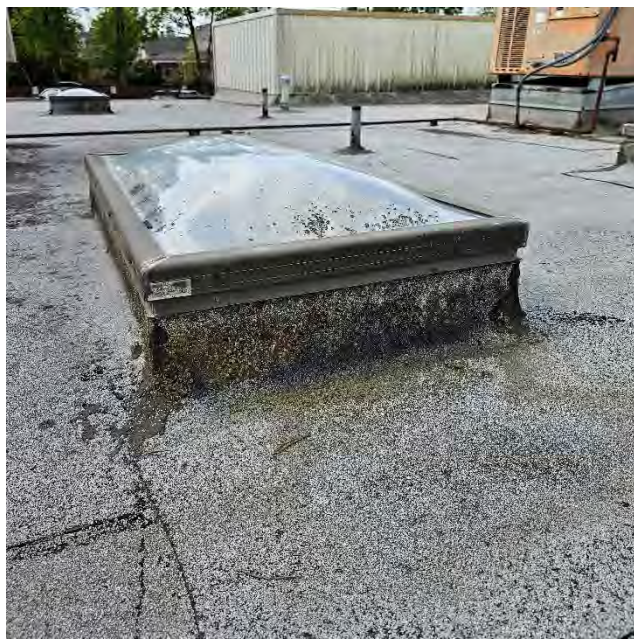
**Photo 2.9:** West roof skylight

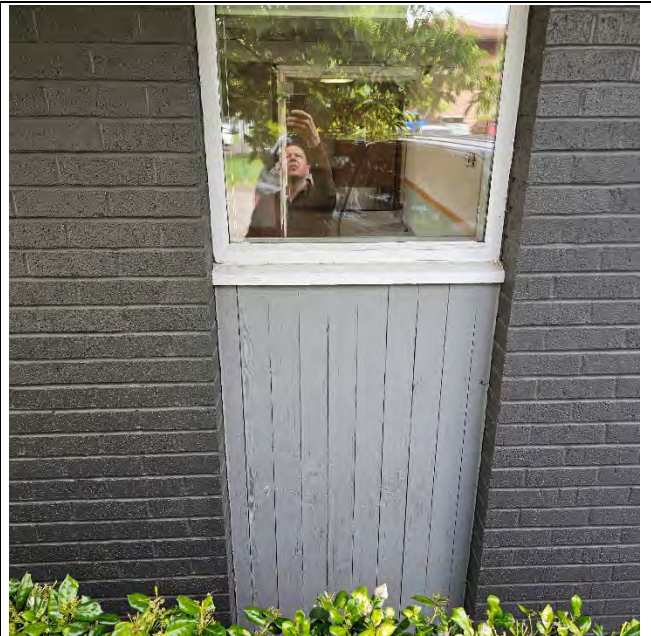
**Photo 3.4:** Vertical wood siding detail

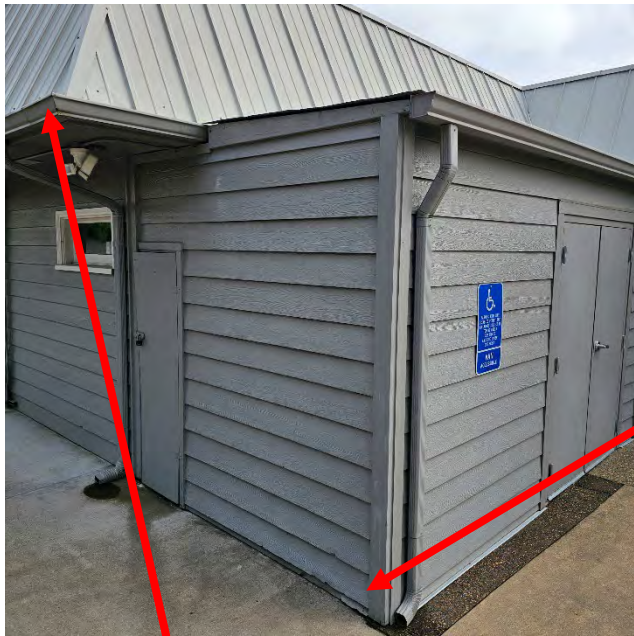
**Photo 3.7:** Cladding overview at SW corner

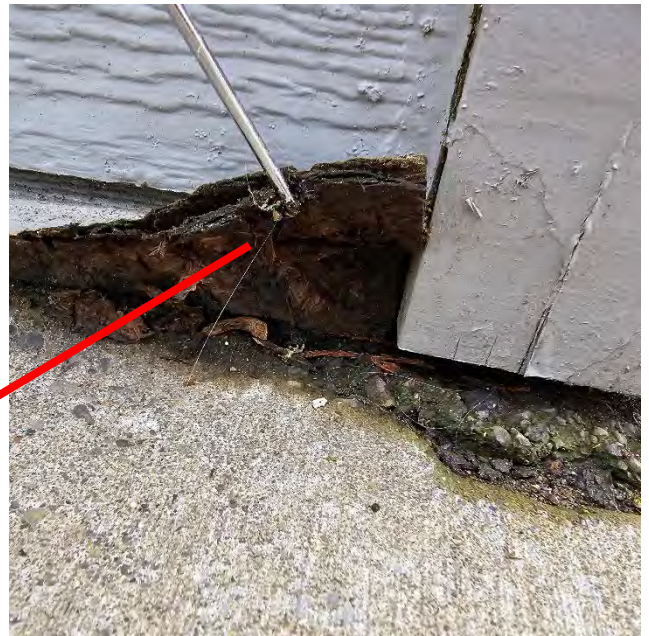
**Photo 3.8:** Exposed wood at transition

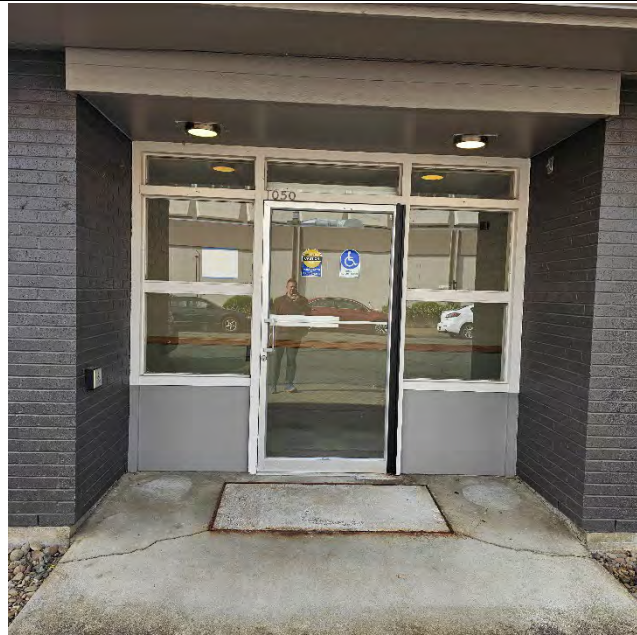
**Photo 4.1:** Entry siding detail (2249, typ)
