1040-1050 7th Ave SW, Albany, OR 97321

**7th St. Due Diligence  
Opinion of Cost  
May 19th, 2024**

Evolution was retained by Linn County Facilities to review the condition and expected service life of existing the existing structure. The building consists of 2 original wood framed structures which were subsequently combined into a single structure.

## Summary Condition Assessment

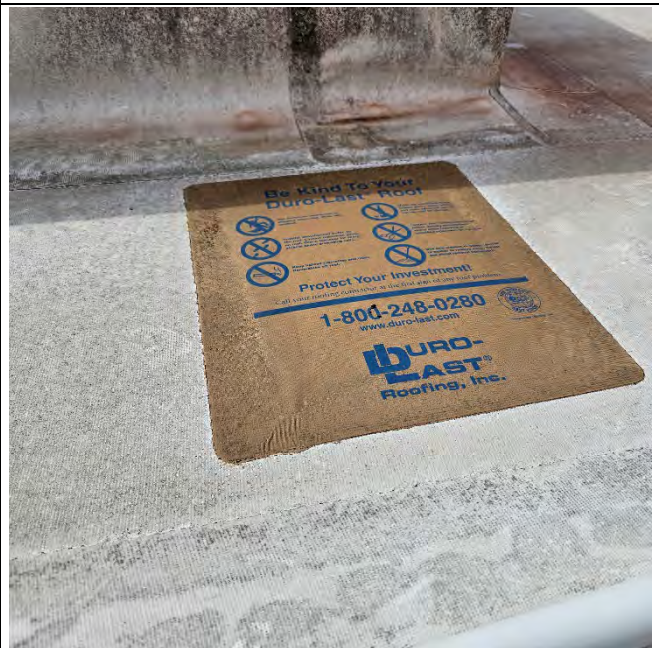
**Photo 2.6:** Manufacturer tag

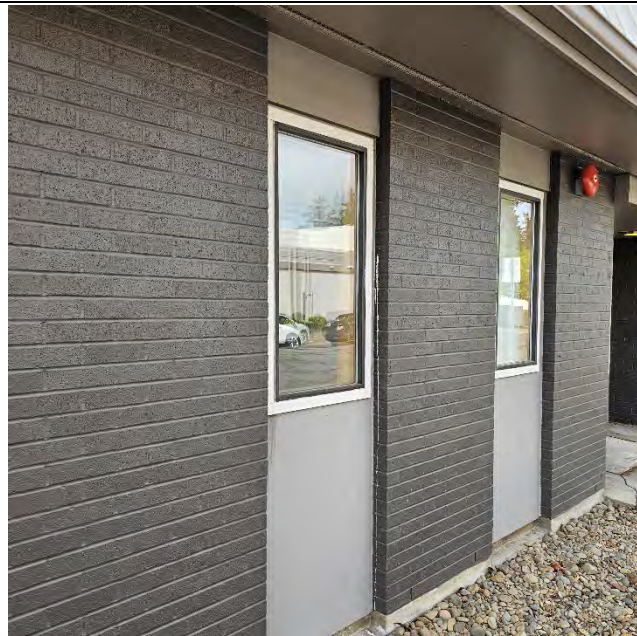
**Photo 3.3:** Brick and vertical wood siding

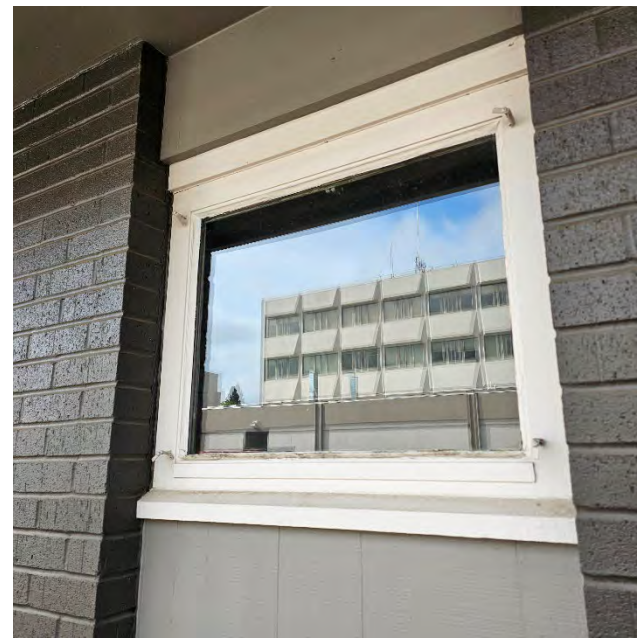
**Photo 4.3:** South curtain wall head detail

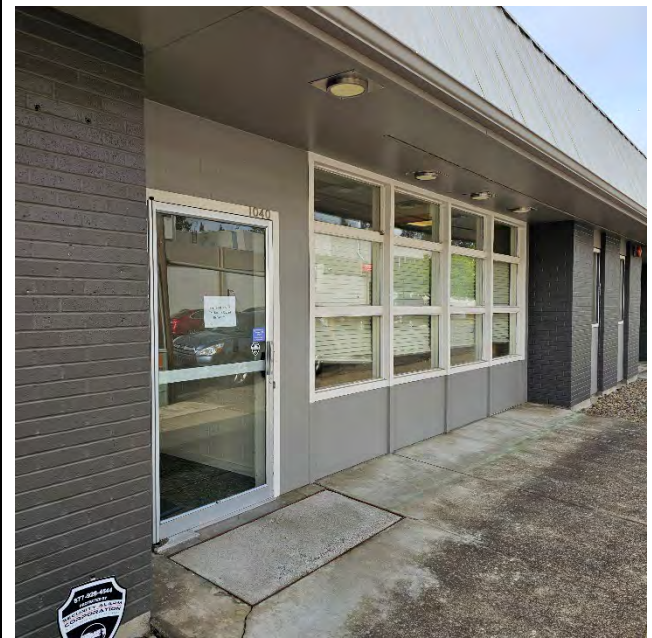
**Photo 4.4:** Curtain wall interior spandrel detail
